INDOOR AIR QUALITY ASSESSMENT

**Framingham High School
115 A Street
Framingham, Massachusetts 01701**

Prepared by:
Massachusetts Department of Public Health
Center for Environmental Health
Emergency Response/Indoor Air Quality Program
October 2005

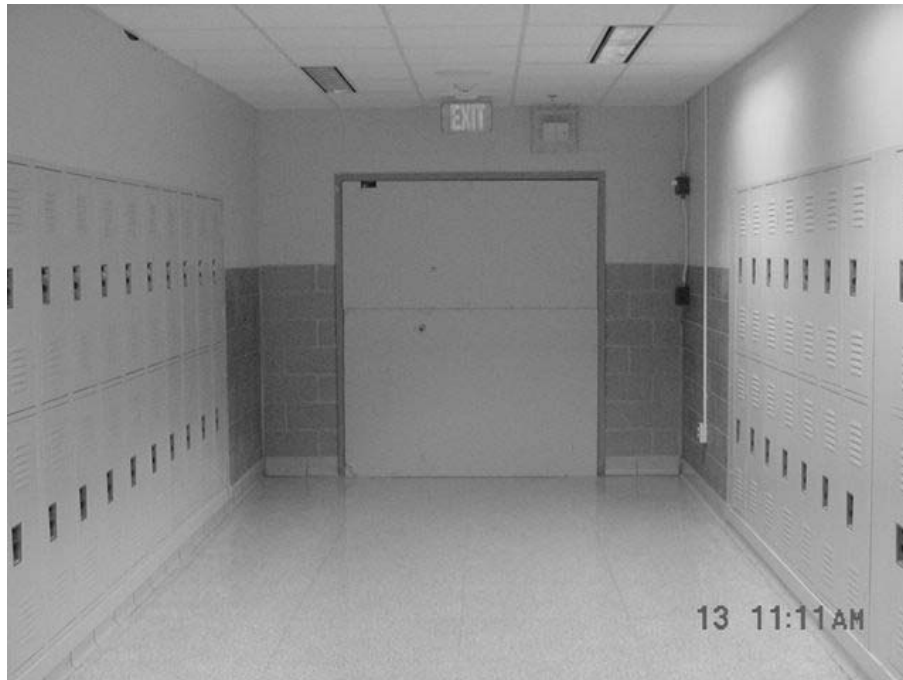
Picture 1

impacted due to close proximity to renovation sites. As previously mentioned, comparison measurements were taken in indoor and outdoor (i.e., background) areas away from renovation sites. Levels of UFPs higher than background levels were measured around containment walls in several areas (Table 1). Breaches were observed around construction barriers from which drafts could be felt and/or light was seen penetrating (Pictures 1 and 2).

Longview of Gypsum Wallboard Construction Barrier

2. Seal construction barriers on all sides with polyethylene plastic and duct tape. Seal these barriers on the construction, as well as the occupied side to provide a dual barrier. Ensure integrity of barriers by monitoring for light penetration and drafts around seams.

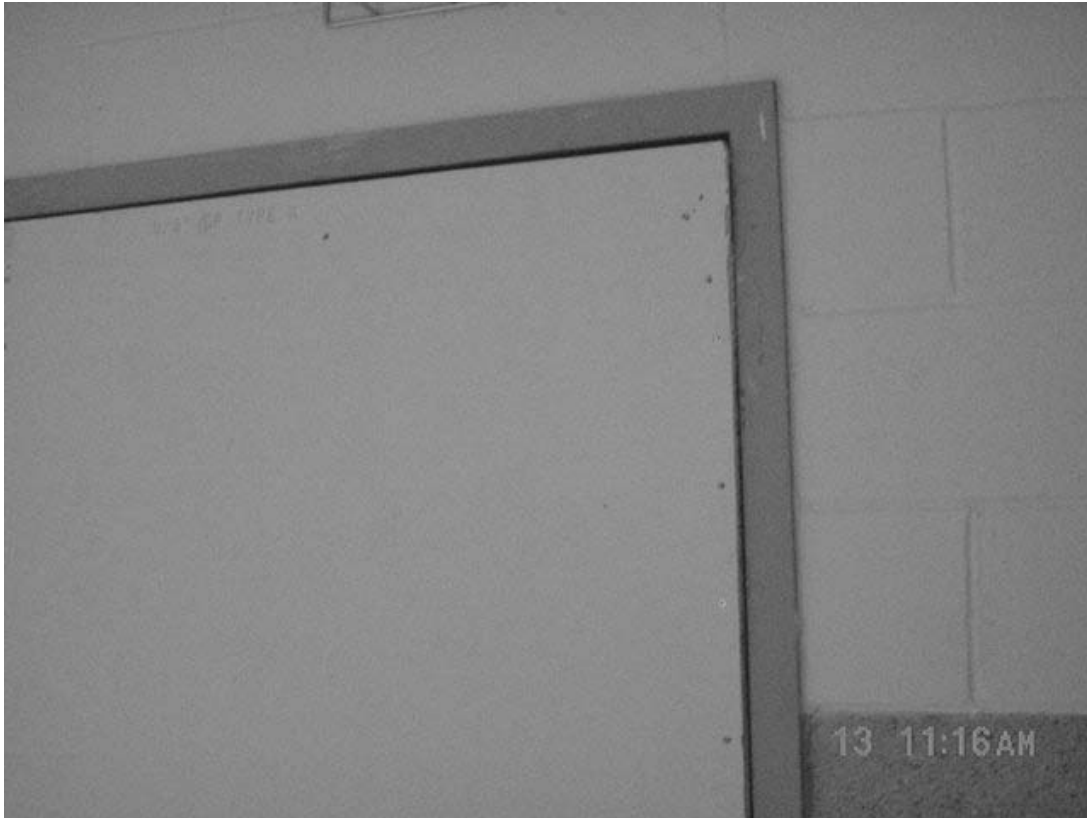
Picture 2

Close-Up of Spaces around Gypsum Wallboard Construction Barrier from which Light Could be Seen Penetrating and Drafts Could be Felt

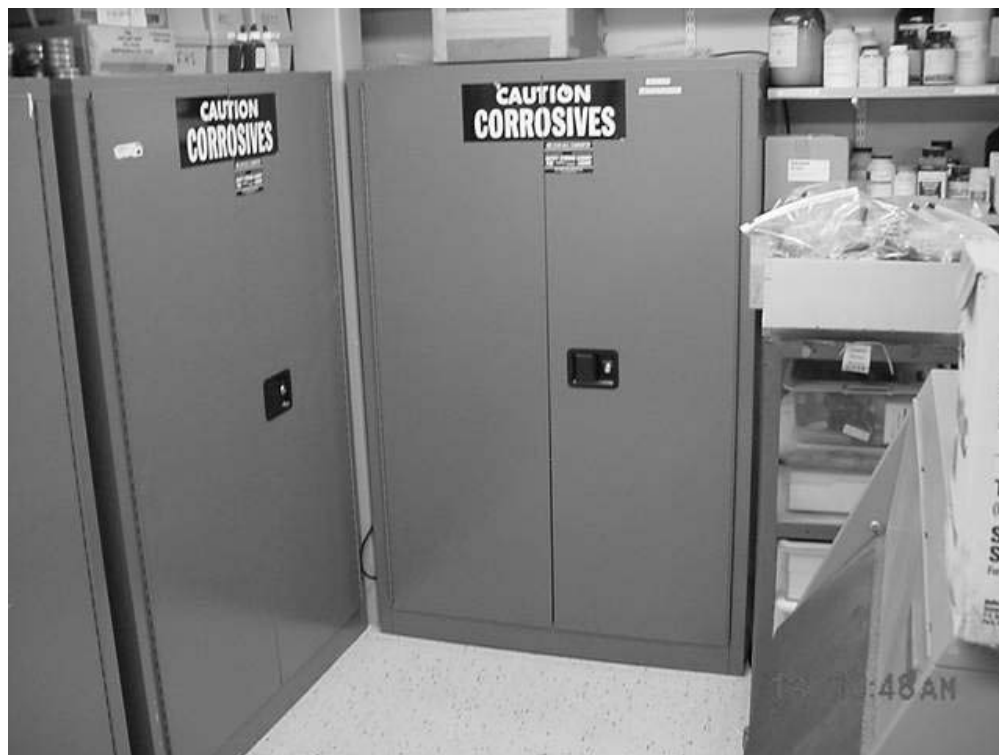
Picture 3

Corrosives Cabinet in Chemical Storeroom C 113

13. Conduct a chemical inventory in the chemical storage room and science labs. Properly store flammable materials in a manner consistent with the local fire code. Discard hazardous materials or empty containers of hazardous materials in a manner consistent with environmental statutes and regulations. Label chemical containers with the chemical name of its contents. Follow proper procedures for storing and securing hazardous materials.

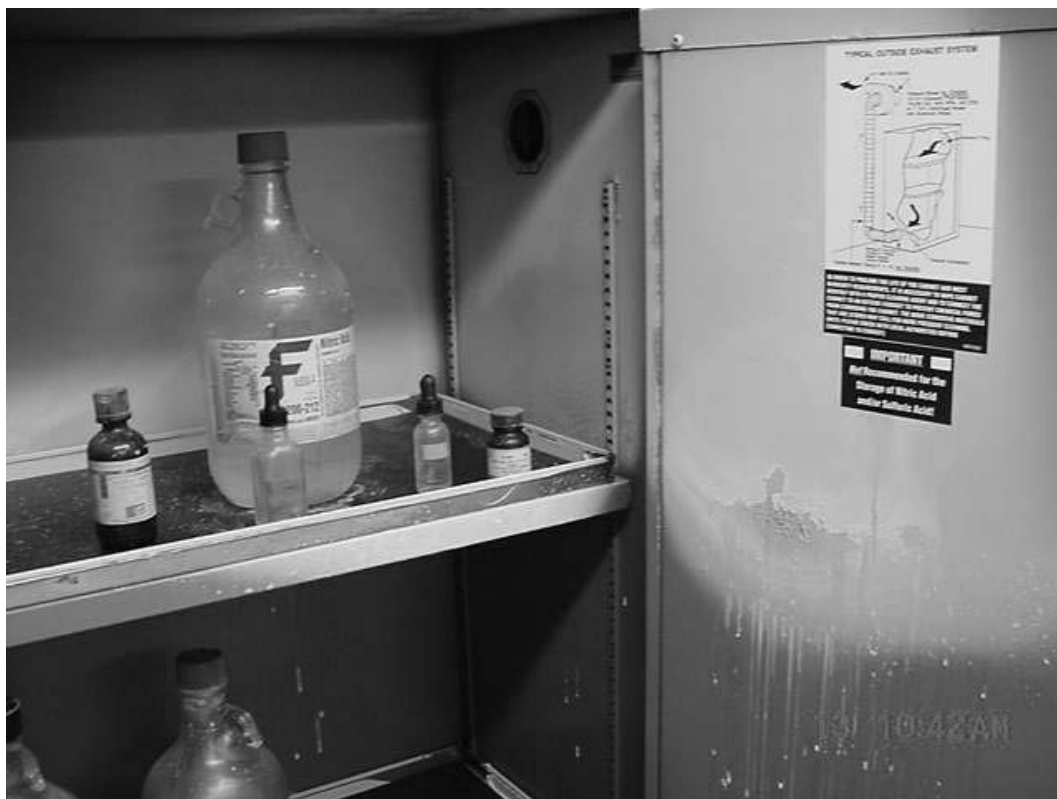
Picture 4

Interior of Corrosives Locker, Note Corrosion and Splashed Pattern of Material on inside of Door

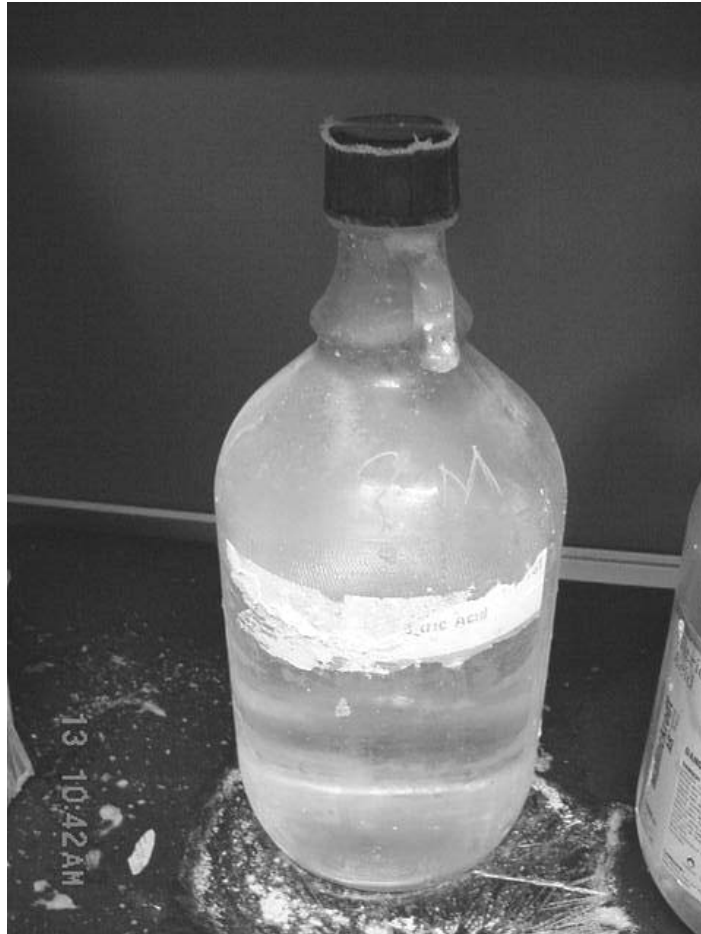
Picture 5

In an effort to determine whether VOCs were present in the building, air monitoring for TVOCs was conducted. An outdoor air sample was taken for comparison. Outdoor TVOC concentrations were ND (Table 1). Indoor TVOC concentrations were also ND (Table 1), with the exception of the chemical storeroom C 114. Measurable levels of TVOCs were recorded at 37 parts per million (ppm) upon opening the “corrosives” locker (Pictures 3 and 4). The source appeared to be from several bottles of acid with damaged caps. Upon closer scrutiny, cracks in the caps and acidic crystal formation were

observed on the containers (Pictures 5 and 6). In addition, the label had become corroded, making it difficult to identify the materials (Picture 5).

Bottle of Acid with Broken Cap in Corrosives Locker, Note Crystallization on Cap, Corroded Label and Debris on Shelf around Bottle

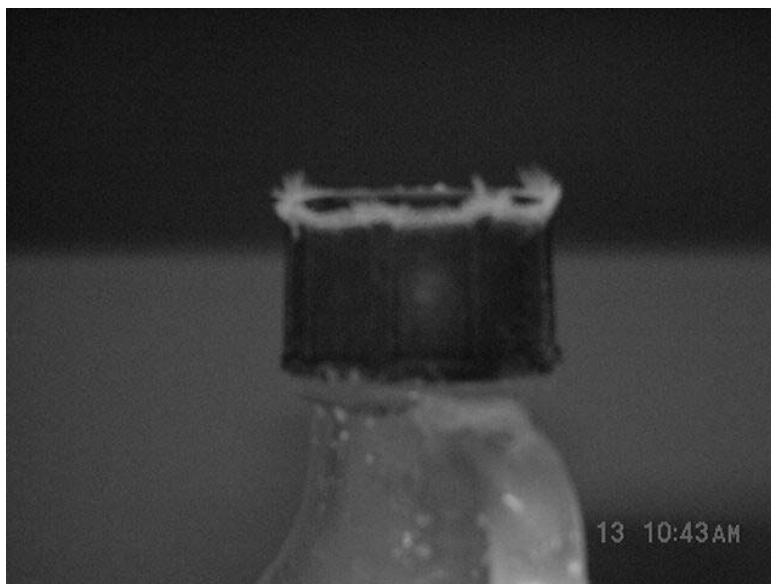
Picture 6

Broken Acid Cap with Crystallization in Corrosives Locker

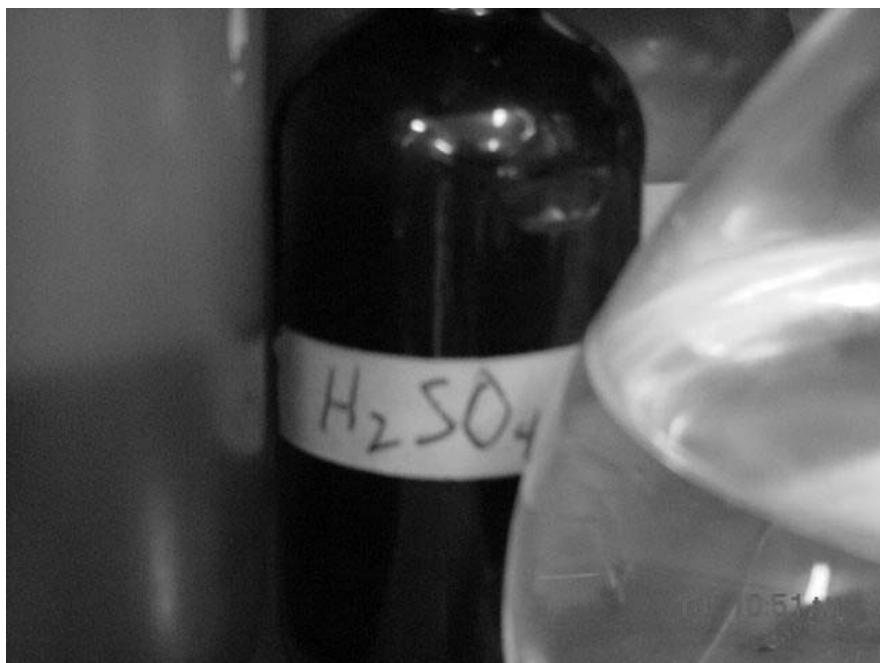
Picture 7

- A number of materials appear to be very old.
- Items were labeled with chemical formula instead of the chemical name (Picture 7).
- Flasks containing chemicals were sealed with parafilm (Picture 8), glass or rubber stoppers. The sealing of these containers can lead to the slow evaporation of materials.
- Several materials were seen stored in laboratory chemical hoods (Picture 9). Stock bottles of chemicals should be returned to chemical storage areas once experiments have been completed.

Bottle Labeled with Chemical Formula

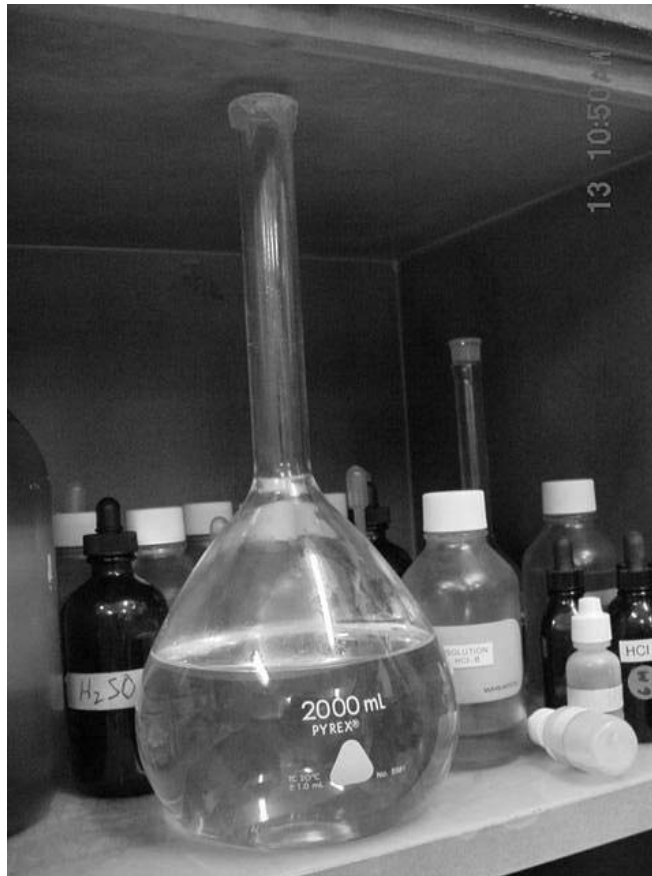
Picture 8

Chemical Flask Sealed with Parafilm

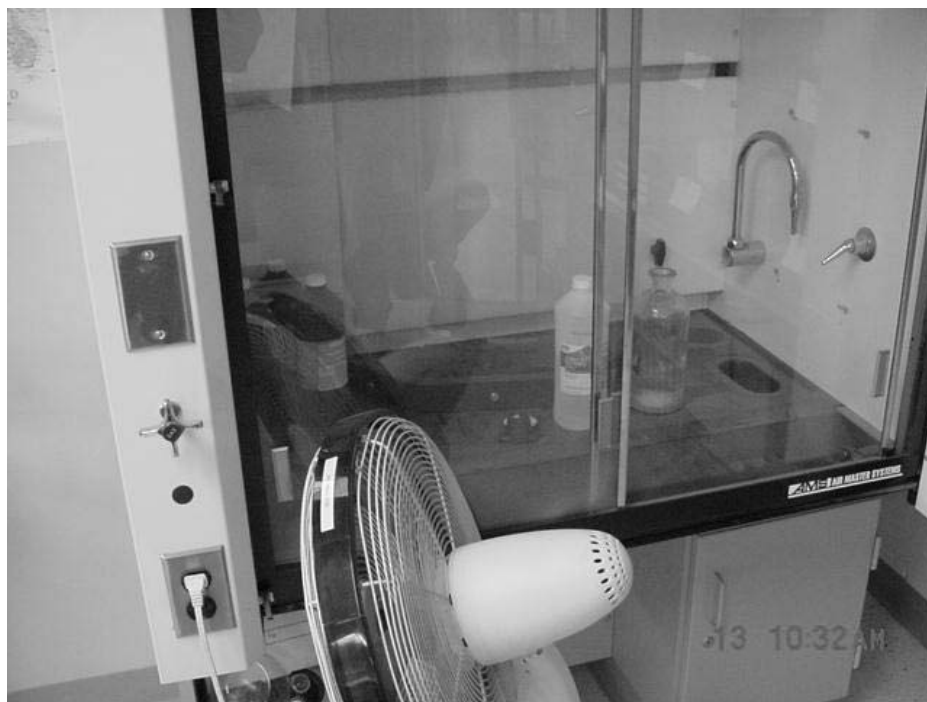
Picture 9

Chemicals Stored in Lab Hood
